January 10, 2025

Project No. 24-7-706

Subject: Geologic Hazards Review, Proposed Commercial ANB Bank, Lot 2, Block 3,
Eby Creek Subdivision, 295 Eby Creek Road, Eagle, Colorado

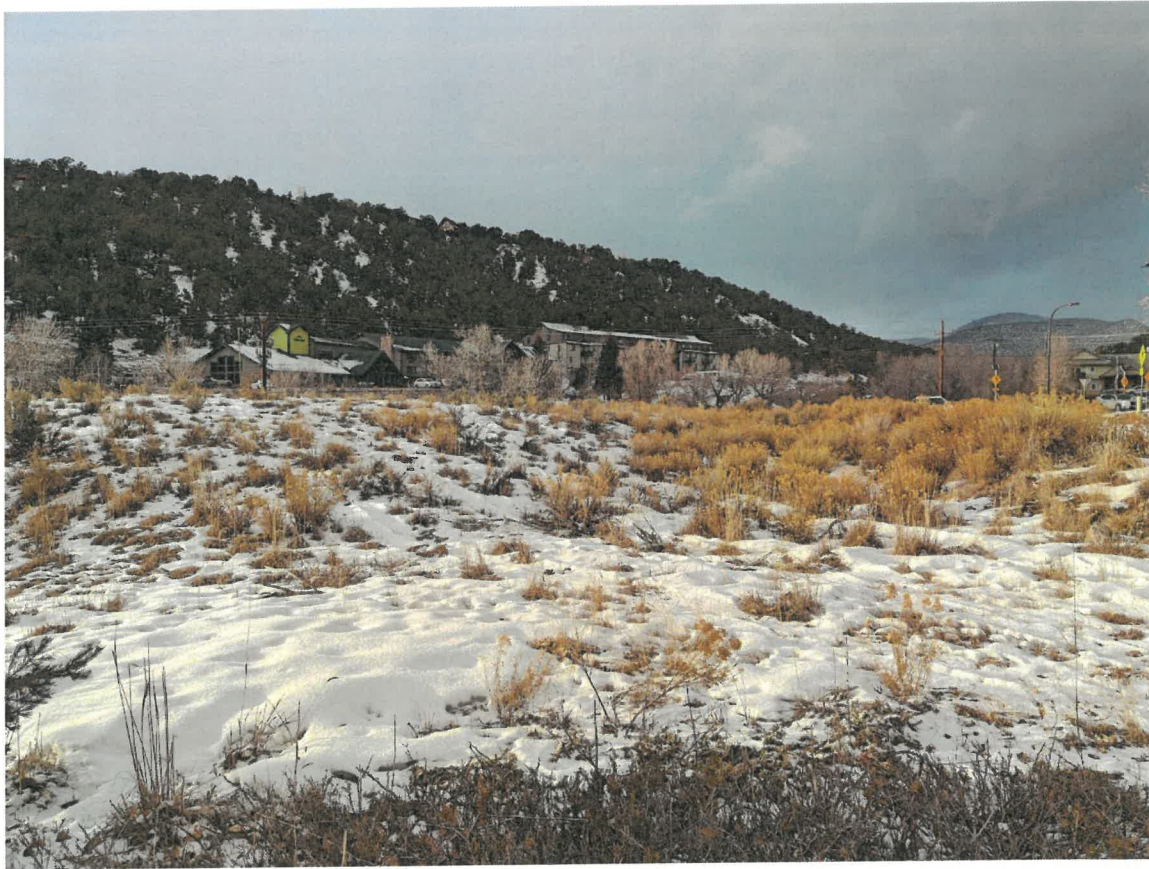
Figure 1. Photograph of the subject lot.

Site Conditions: The southern portion of the subject site is currently occupied with a single-story commercial building with paved access and parking areas. Topography at the site is valley bottom with gentle slopes of about 3 to 10 percent grade down to the southwest in the building area with slopes up to about 25 percent to the west and south of the proposed building area. Elevation difference across the lot is about 20 feet. Vegetation consists of landscaped bushes and deciduous and coniferous trees in the developed areas and native grass and weeds in the undeveloped area. A recent photograph of the lot is shown below.

The debris fan hazard is due to the drainage channels that outlet to the north of Interstate 70, north of the subject lot. No signs of recent debris flow or hyperconcentrated flow were observed on the subject lot or near the subject lot along Eby Creek. Eby Creek is well channelized at a lower elevation than the site. It is not expected that any debris flow/hyperconcentrated flow originating from the drainage channels north of the subject site will impact the subject lot. It is our opinion that no further debris flow analysis or mitigation is warranted.
