Re: Reserve at Hockett Gulch Site Visit Report  
WJE No. 2018.5122

Wiss, Janney, Elstner Associates, Inc. (WJE) understands that the Reserve at Hockett Gulch residential development is being planned on an approximately 30-acre site located approximately 1,000 feet south of the intersection of Highway 6 and Sylvan Lake Road in Eagle County, Colorado (Figure 1). The site slopes gently to the northeast and contains steep, eroded slopes south of the proposed development. Hockett Gulch, a prominent drainage feature south of the site, exits the steeper terrain and has created an alluvial fan in the development area. In its preliminary geotechnical report dated September 20, 2015, Hepworth-Pawlak Geotech (HP Geotech), identified potential debris flow/debris flood hazards associated with Hockett Gulch. Consequently, WJE was tasked with assessing potential debris flow/debris flood hazards and recommending risk mitigation, if applicable. As the initial step in this assessment, Emma Bradford, EI, and Michael W. West, PhD, PE, PG, , performed a preliminary site reconnaissance on August 1, 2018, to assess debris flow/debris flood hazards and associated risks to the proposed project.

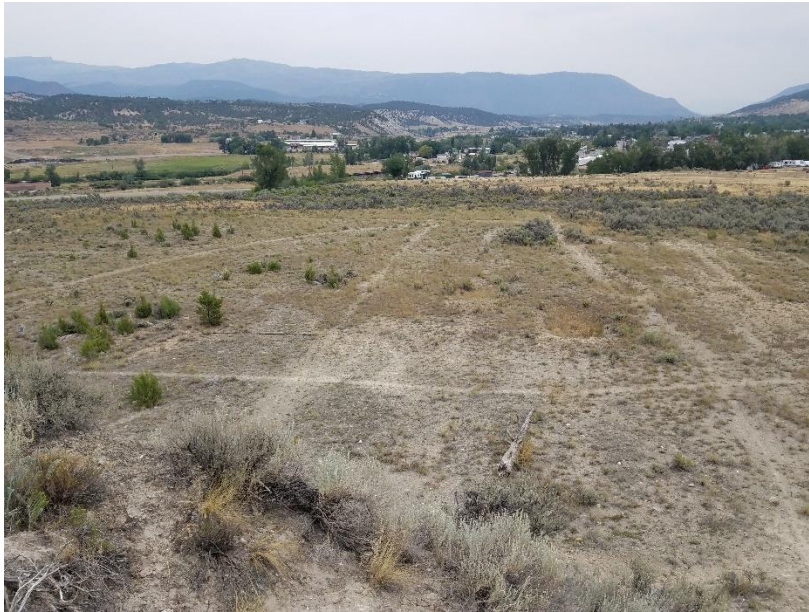
- The relatively flat site area is covered in greyish-tan silty soils deposited in an alluvial fan issuing from Hockett Gulch (Photo 1).
  - Evidence of erodible soils was observed (Photo 2).

*Photo 1. Silty soils covering site area on the Hockett Gulch alluvial fan.*

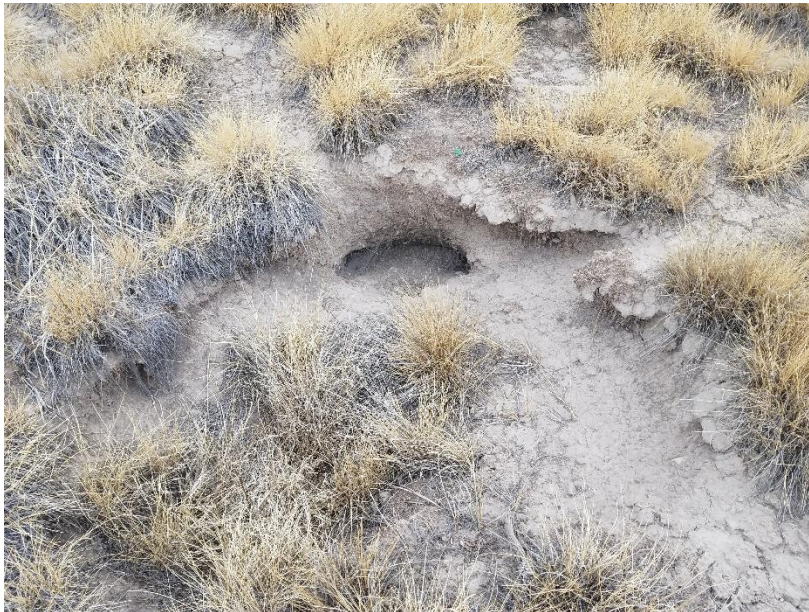
*Photo 2. Evidence of erodible silty soils.*

We recommend WJE personnel return to the site to map it, and appropriate surrounding areas, in detail prior to submitting the Development Permit by the Town of Eagle. Specifically, nearby potential source areas will be evaluated for the potential to produce a debris flow. Evidence of collapsible and erodible soils will be identified and evaluated for impact on future development. In addition, we will identify significant anthropogenic features at the site that can be visually observed. WJE plans to coordinate future work with the Colorado Geological Survey to reasonably assure that government planning requirements are satisfied.

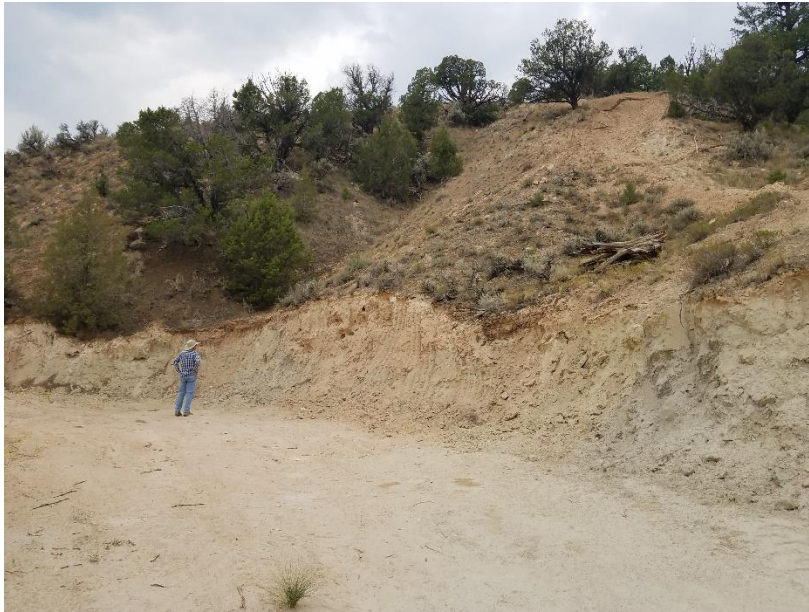
- The steep slopes that flank Hockett Gulch and associated side ravines to the south side of the development site are underlain by weathered Eagle Valley Evaporite (Photos 3, 4, and 5).

*Photo 3. Highly weathered Eagle Valley Evaporite exposure along service road leading to Hockett Gulch.*

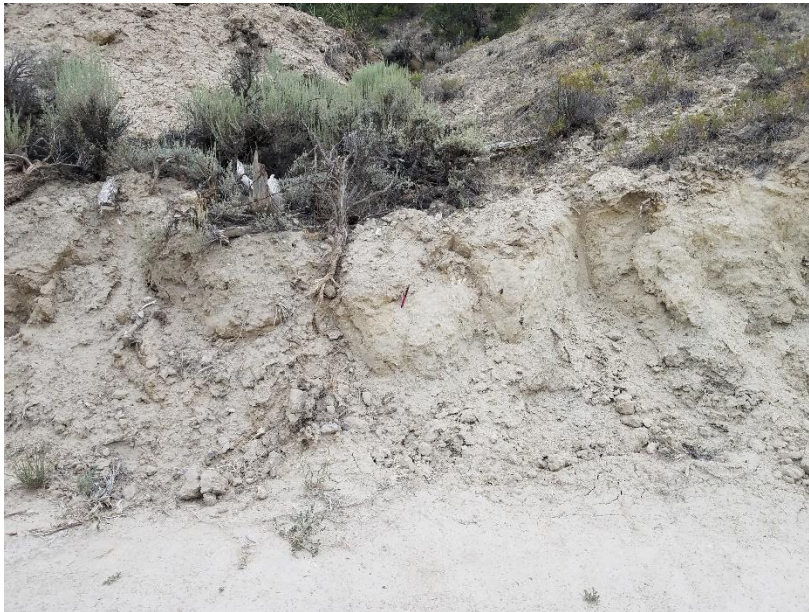
*Photo 4. Highly weathered Eagle Valley Evaporite exposure along service road leading to Hockett Gulch.*

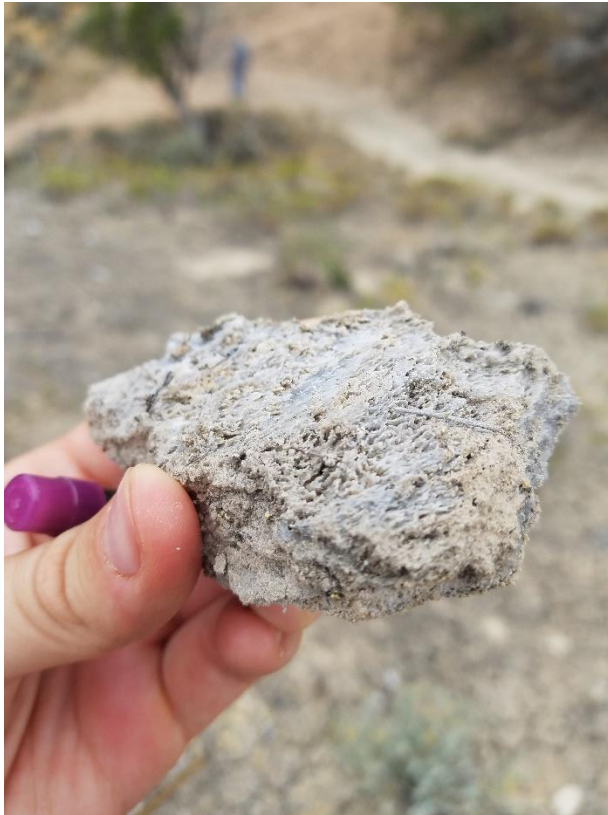
*Photo 5. Small cobble-sized clast of Eagle Valley Evaporite found in Hockett Gulch.*

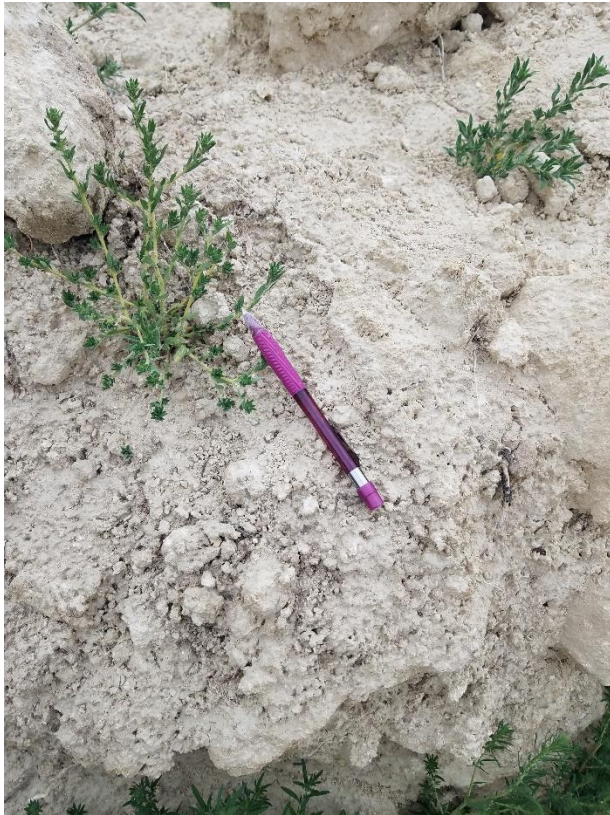
- Some exposures of Eagle Valley Evaporite are covered with a thin silty alluvium that exhibited a popcorn-like texture (Photo 6).
  - Blocks of evaporite removed by excavation were observed in Hockett Gulch a short distance away from the site (Photo 7).

*Photo 6. Popcorn-like texture of residual Eagle Valley Evaporite soils.*

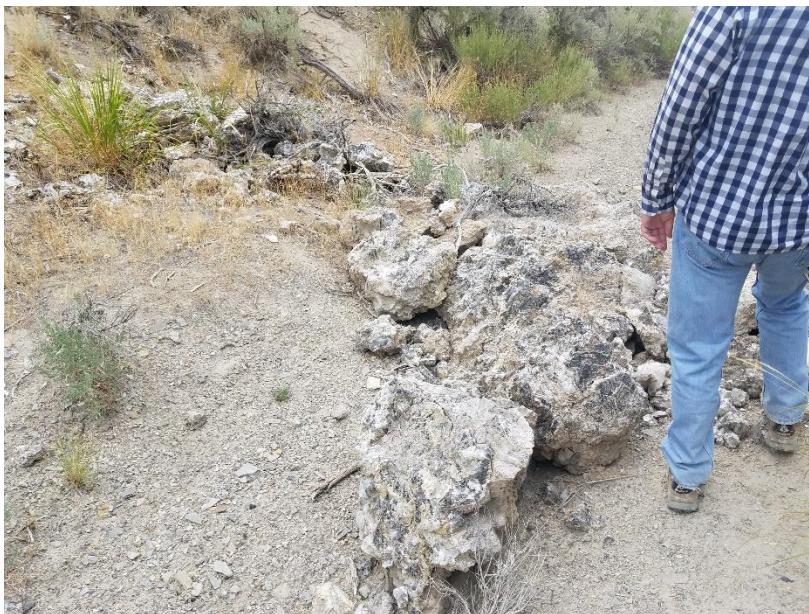
*Photo 7. Cobble- to boulder-sized Eagle Valley Evaporite clasts, removed by excavation, south of the site in Hockett Gulch.*

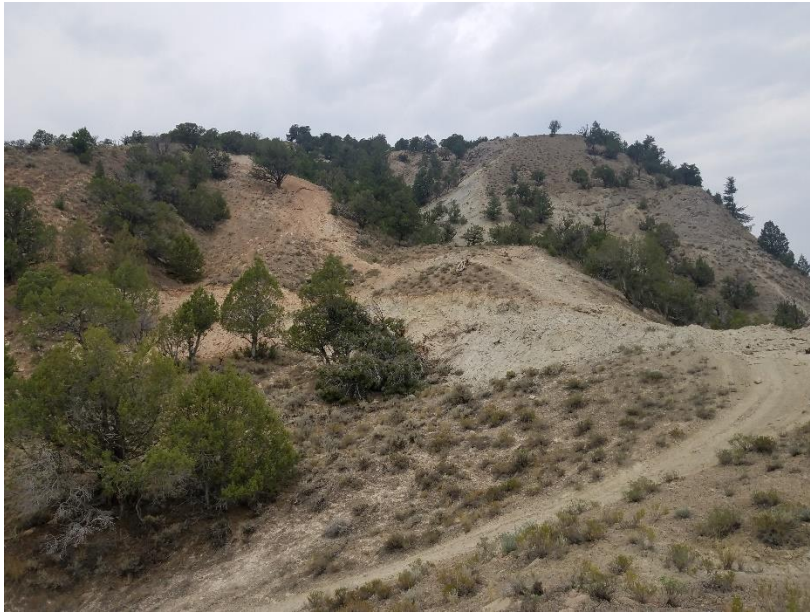
- The terrain to the south of the site contained contorted bedding as a result of dissolution and collapse (Photo 8).
- Multiple fan deposits of varying sizes composed of silt-dominated soils have been deposited from small ravines in steeper terrain along the south side of the development area, east of Hockett Gulch. These fan deposits interfinger with and overlie the larger fans associated with Hockett Gulch (Photo 9).

*Photo 8. Irregular topography within the Eagle Valley Evaporite.*

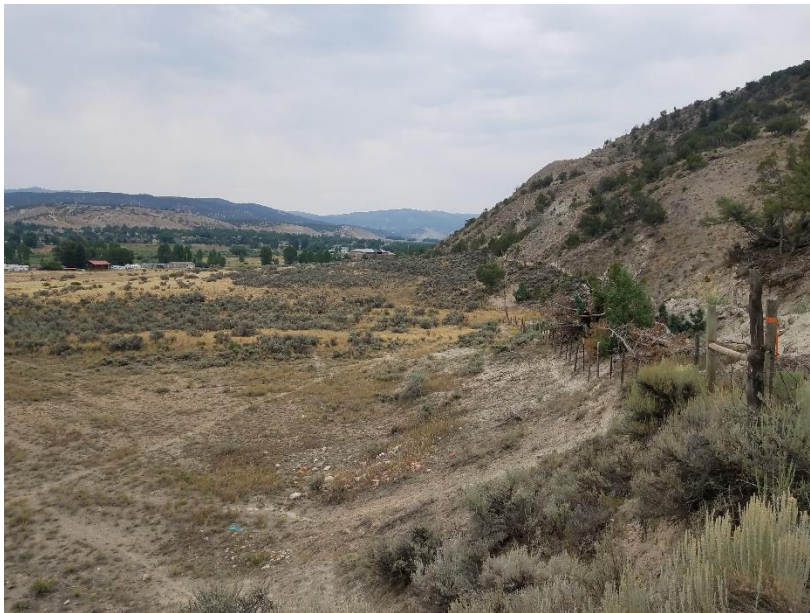
- No boulders, cobbles, or significant amount of gravels were observed within or surrounding these fans at the surface.
  - Fans were vegetated with native grasses and sage brush.

*Photo 9. View of relatively smaller fan deposits, issuing from higher terrain along the south side of the development site.*

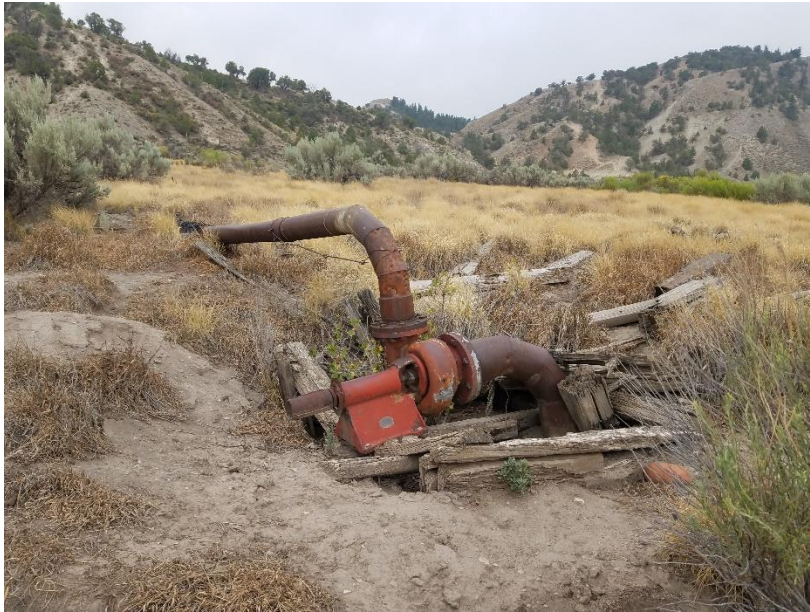
- Various cultural features were observed including metal pipe remnants, a culvert, man-made earthen berms, etc. (Photos 10 and 11).
- An active, west-east-oriented, high pressure gas pipeline runs through the development site.

*Photo 10. Abandoned pipeline parts.*

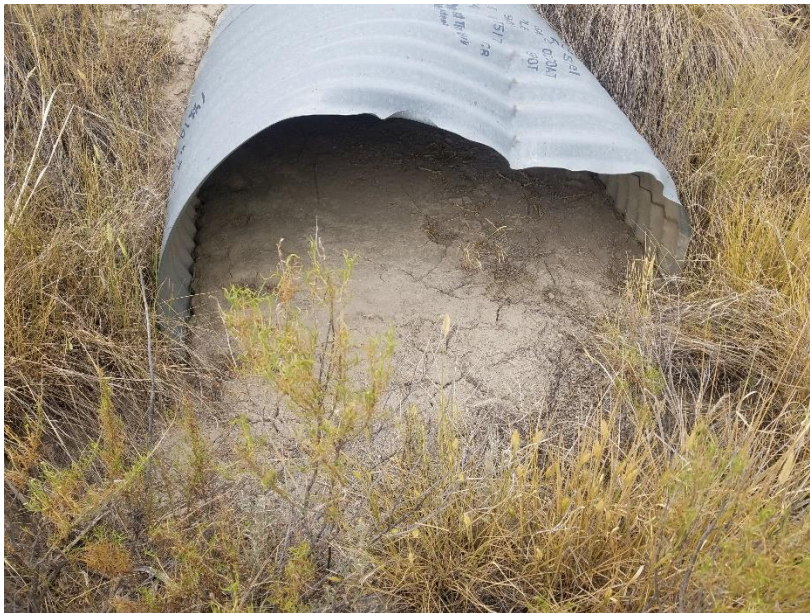
*Photo 11. Culvert full of dried silty material exhibiting desiccation cracks.*

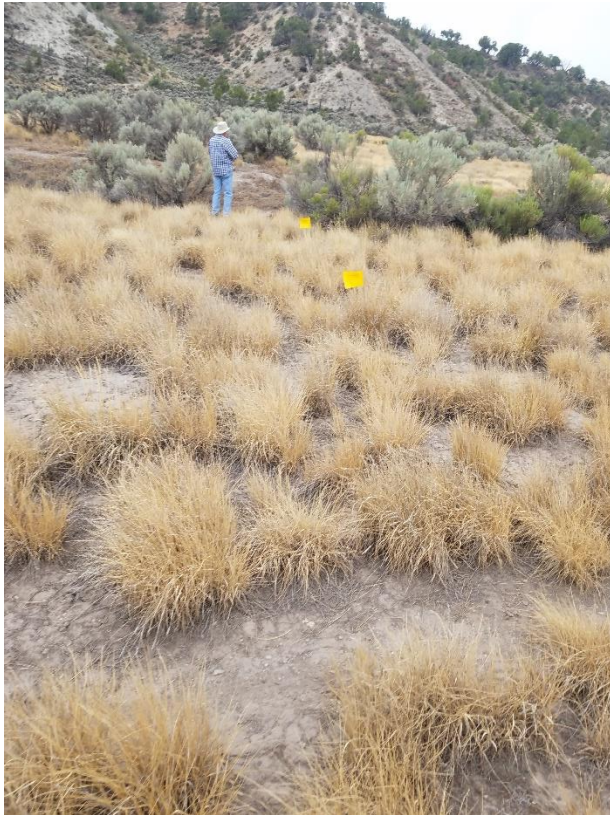
*Photo 12. High pressure gas pipeline route indicated by yellow flags.*
